FIELD INVESTIGATION SURVEY OF AIRTIGHTNESS, AIR MOVEMENT AND INDOOR AIR QUALITY IN HIGH RISE APARTMENT BUILDINGS PRAIRIE REGION

B.W. Gulay, P.Eng.
C.D. Stewart, P.Eng.
Wardrop Engineering Inc.
400-386 Broadway
Winnipeg, Manitoba
R3C 4M8

November, 1991

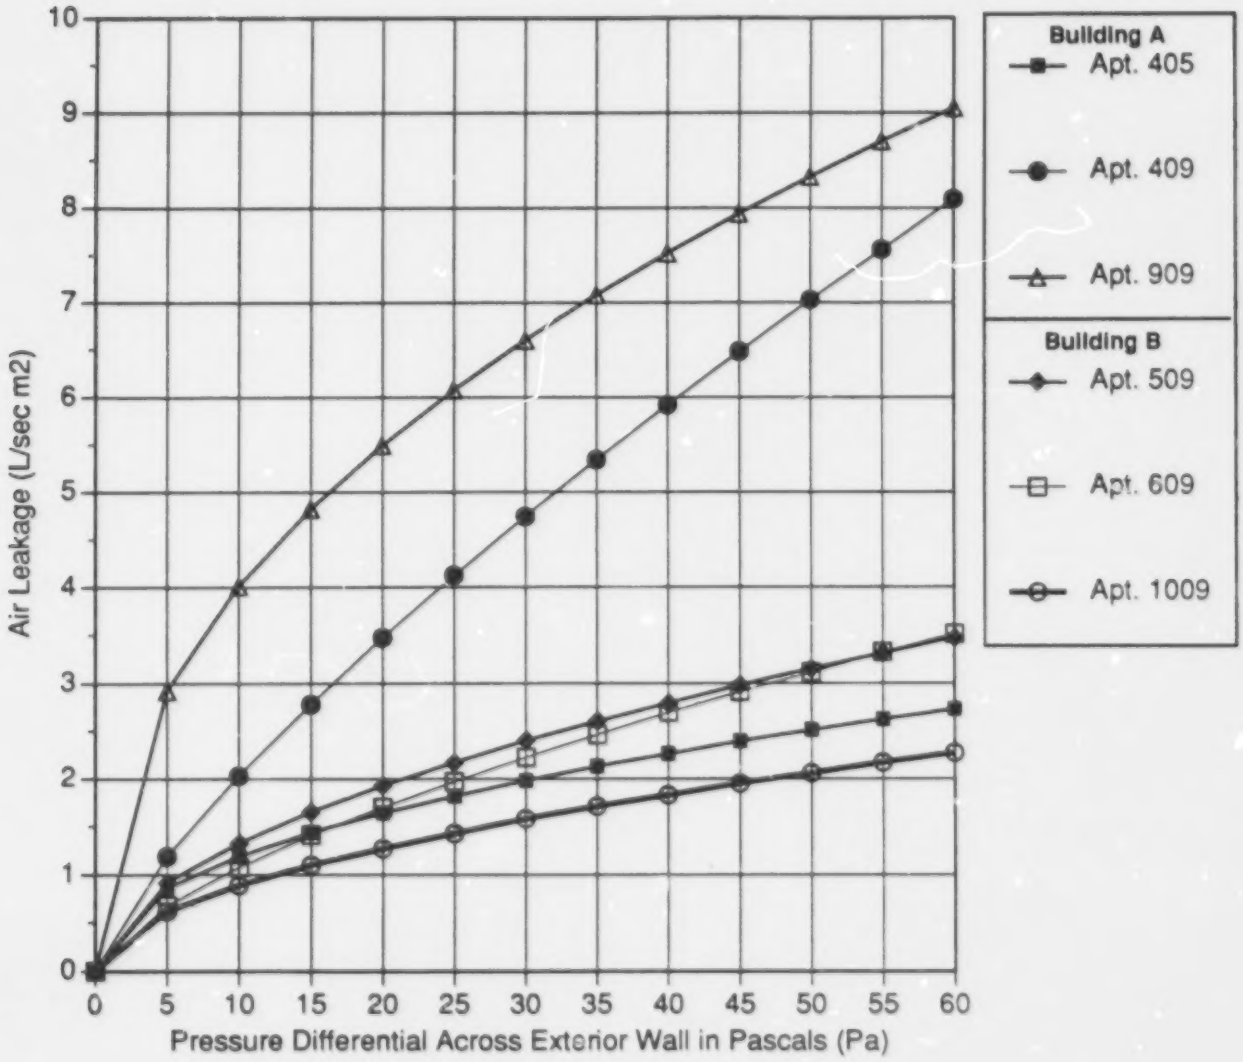
Figure 1

Note: Overall Air Leakage Rates for Building A Apartments 409 & 909 are for Combined Exterior Wall & Corridor Leakage

The overall air leakage rates per unit area of exterior wall for Buildings A and B are in the range of 2.06 to 3.15 L/sec.m^2 at a pressure differential of 50 Pa. By comparing the average of the three exterior wall leakage rates obtained for Building B with the sole similar test conducted for Building A, it was found that Building A was approximately 10% tighter than Building B. The exterior wall leakage rates are presented graphically on the page opposite.

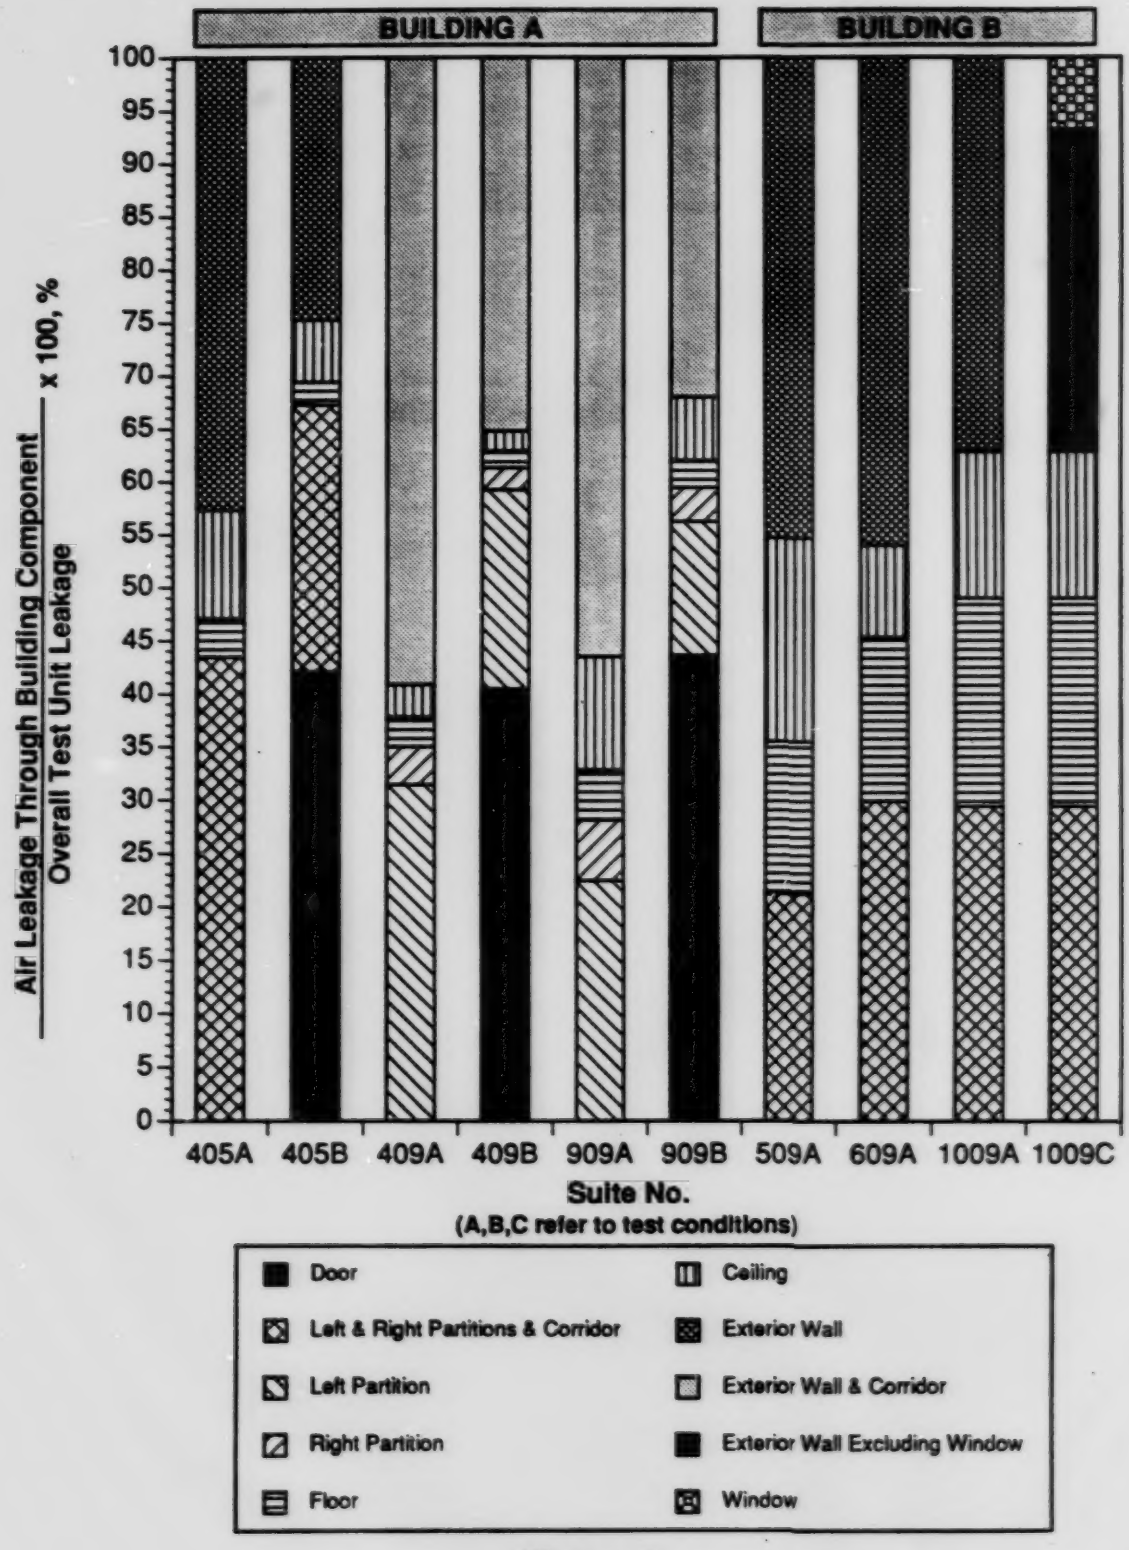
Figure 2

Ratio of Component Air Leakage to Overall Leakage For Individual Apartment Units, ΔP=50 Pa

The largest single air leakage component was the suite entry door at 41.5% of the total six-sided leakage. While not unexpected, the magnitude of the door leakage should be noted, particularly since the testing procedure described by Shaw (circa 1990) does not include its determination. This large leakage rate can be attributed to the entry doors being deliberately undercut across the bottom to allow for the passage of supply air from the slightly pressurized hallway into the individual suites. This type of air flow should have little direct effect on the transportation of odours between adjacent suites, but would have substantial effect if the odour was present in the hallway.

The second largest leakage component was through the exterior wall. Where the suite is below the neutral pressure plane, the result is air infiltration. If the rate of infiltration is sufficient to compensate for the hallway pressurization, odours will migrate into the hallways. If the suite is above the neutral pressure plan, the leakage through the exterior wall is exfiltration. Again, this type of leakage will have little direct effect on the transmission of odours between suites.

The leakage rates for the individual partition and corridor walls vary widely, but when averaged, each account for approximately 6.3% of the total leakage. This was essentially the same leakage rate found for the floors at 6.2%, and the ceilings at 6.7%. It is this direct type of suite to suite flow of air that is believed to be the major source of odour transmission within these apartment buildings.

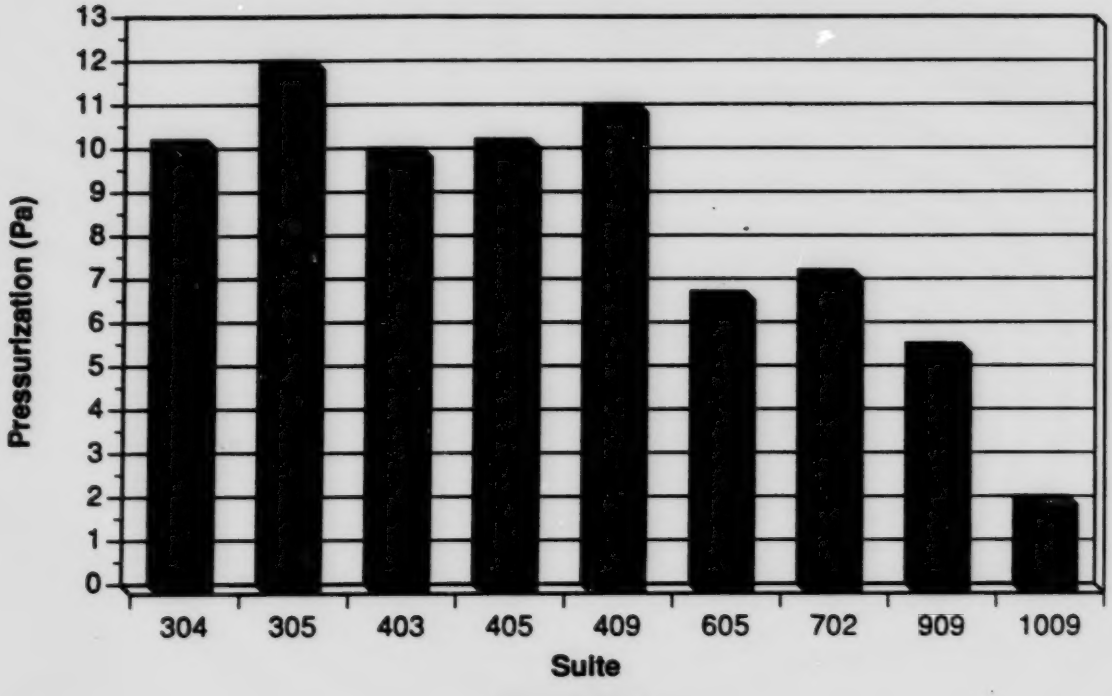
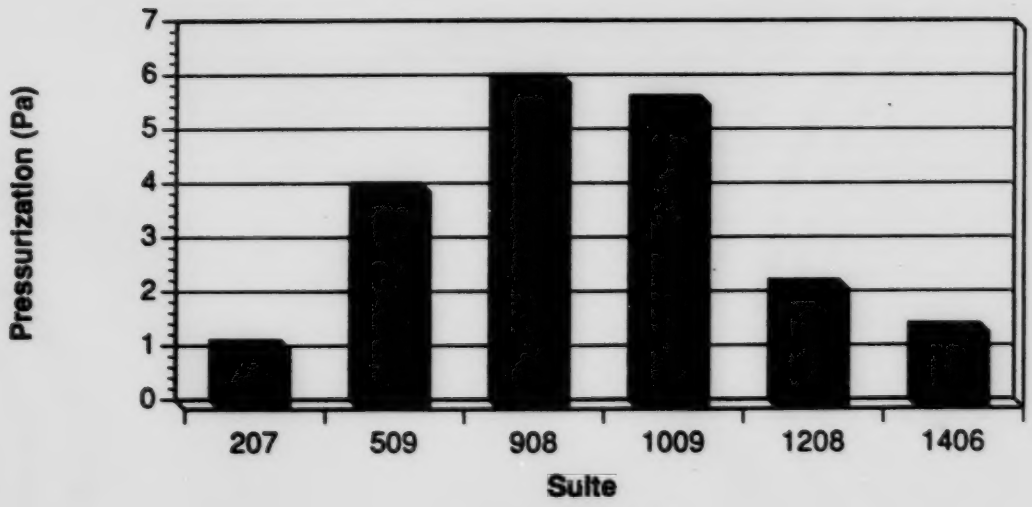
Figure 3 & 4

The building envelope pressurization created by the mechanical ventilation system in Buildings A and B are shown on the attached Figures 3 to 6. In general, the ventilation system pressurized the building envelope by 4 to 12 Pa on the lower floors, and by 2 to 7 Pa on the upper floors. Variations in the upper and lower floor pressurization are believed to have been caused by tenants on upper floors keeping their windows slightly open at the time of testing. The tenants are instructed by the building owner to keep their windows closed during the winter heating season, but this rule is not always observed.

The magnitude of mechanical pressurization found has two important influences on these buildings. The first is to lower the height of the neutral pressure plan, see page following. This results in an increased area of the building envelope being subjected to positive internal pressurization. The second is to increase the magnitude of pressurization across the building envelope. These two conditions combined could greatly increase the moisture transportation and deposition through the building envelope.

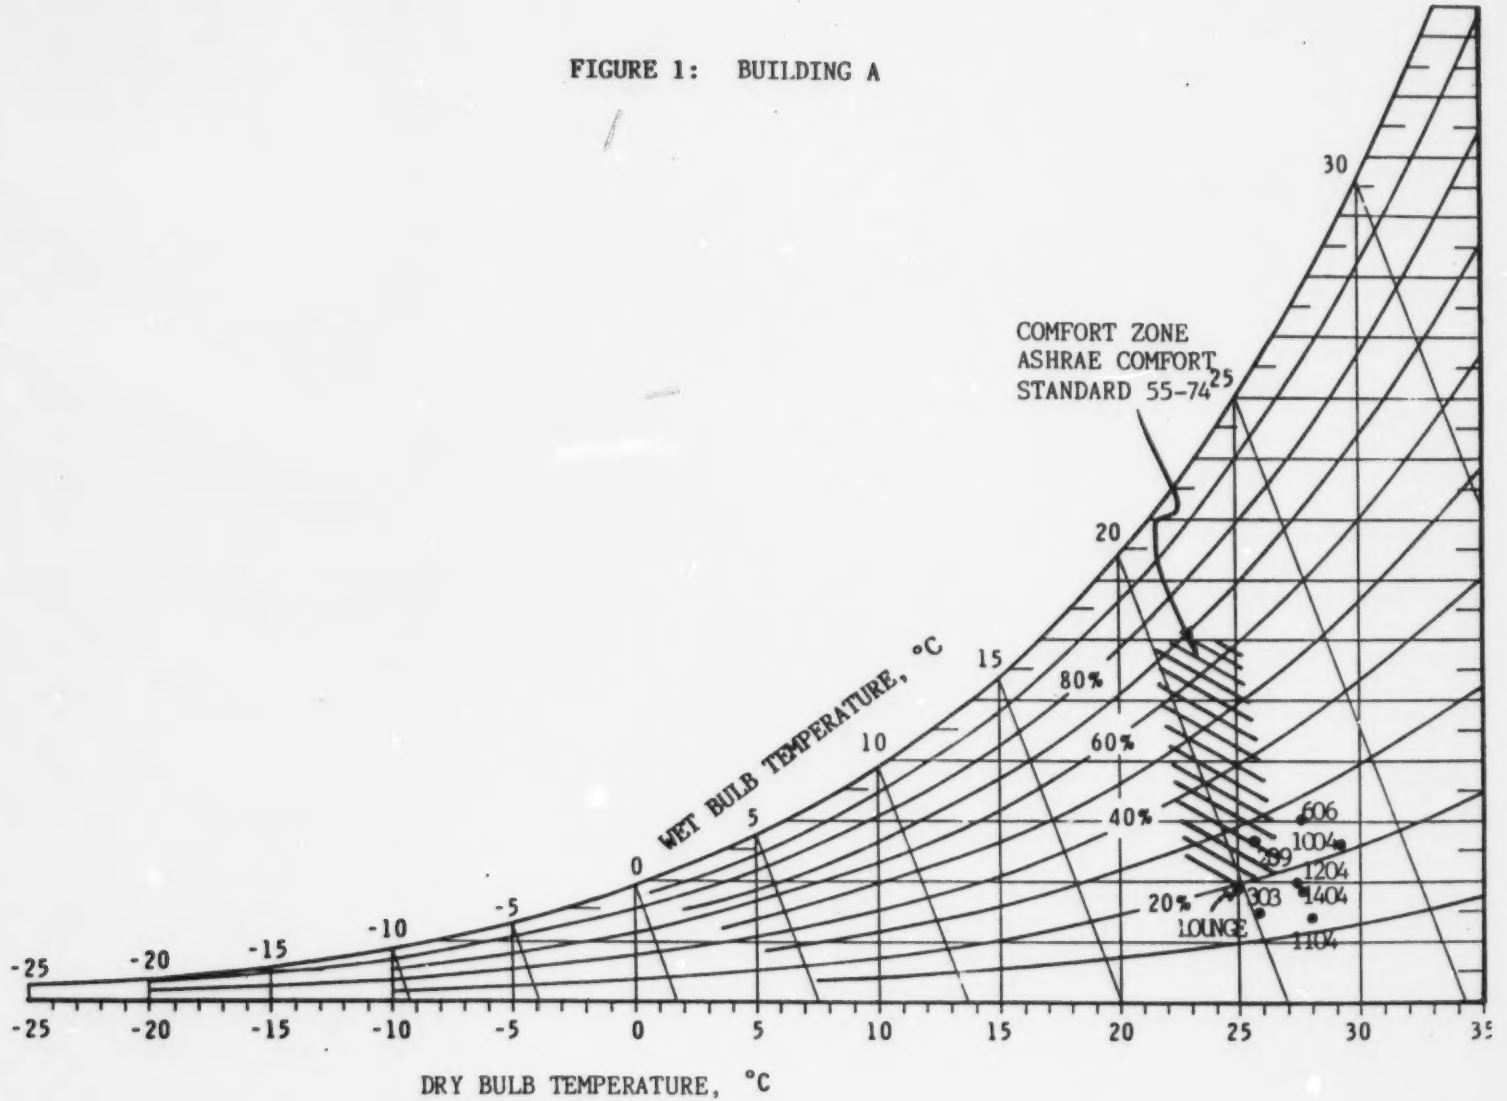
FIGURE 1: BUILDING A

The combination of dry bulb temperatures and corresponding relative humidity levels can be plotted on a psychometric chart to see whether these values fall within ASHRAE Comfort Standard 55-74. Seven out of eight locations tested in Building A fall outside the comfort zone, confirming a warm, dry environment. All eight locations tested at Building B fall outside the comfort zone.
